Coastal Protection and Restoration Authority of Louisiana

2008 Annual Inspection Report

POINT AU FER ISLAND HYDROLOGIC RESTORATION (TE-22)

State Project Number TE-22
Priority Project List 2

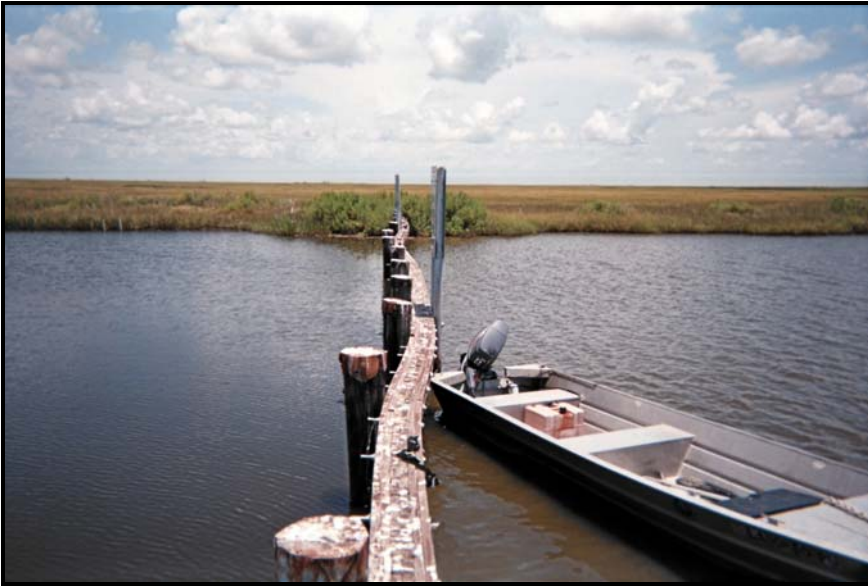
The timber bulkhead is in good condition. The breach around the south end noted in previous inspections was closed in 2005 by construction of a vinyl sheet pile bulkhead extension approximately 60' in length. The concrete mats (scour pad) have limited the erosion at the south tie-in. The north tie-in at the canal bank had no apparent signs of erosion. The warning signs and supports were in good condition. No maintenance will be required at Plug No. 8.

Photo 1. *Plug No. 8 – View of plug looking north along timber bulkhead in Hester Canal. Date of photo: 6-25-2008.*

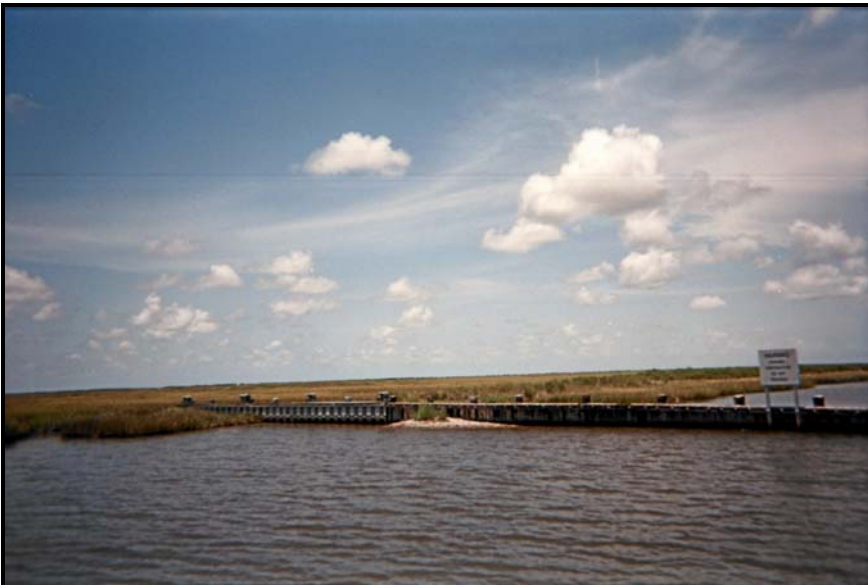
Photo 2. *Plug No. 8 – View of south bank tie-in and 2005 maintenance extension of sheet pile wall. Date of photo: 6-25-2008.*

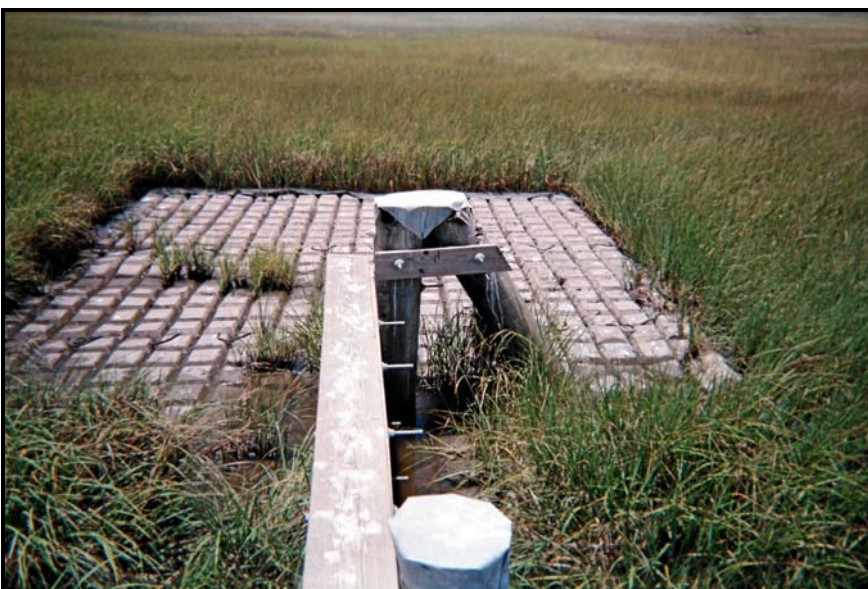
Photo 3. *Plug No. 8 – View of south tie-in at end of 2005 maintenance extension of sheet pile wall. Submar mat scour pad can be seen. No new scour or erosion of marsh was noted at the tie-in. Date of photo: 6-25-2008.*

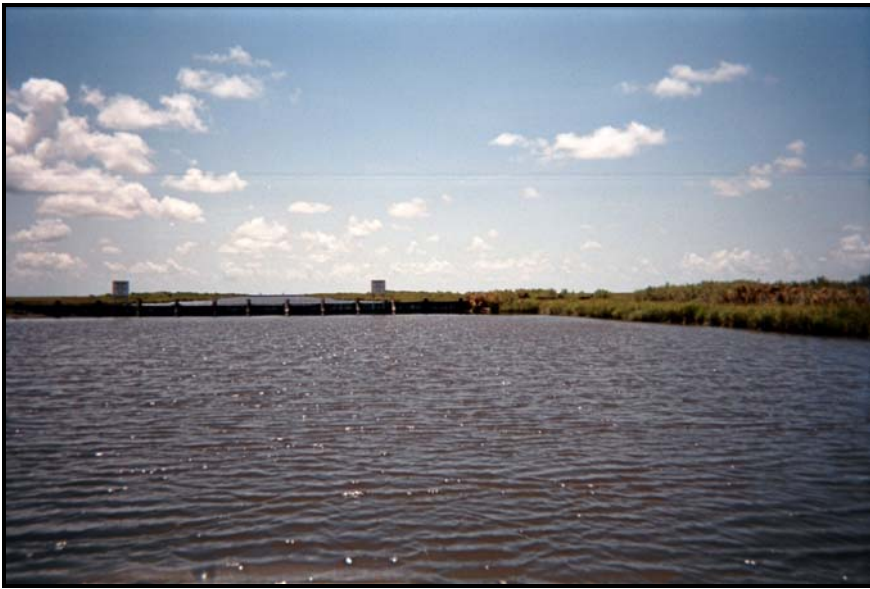
The timber bulkhead plug located across Hester Canal east of Transco Canal appeared to be in good condition with no noticeable structural defects. The tie-ins at the banks had no apparent signs of erosion. The warning signs and supports were also in good condition. No maintenance will be required at Plug No. 7.

Photo 4. *Plug No. 7 – View of plug from inside looking southeast in Hester Canal. Date of photo: 6-25-2008.*

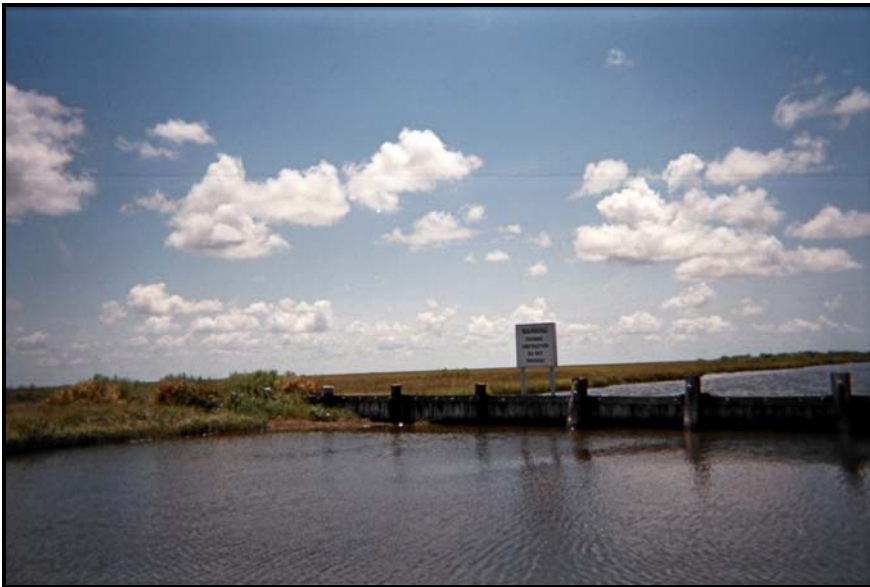
Photo 5. *Plug No. 7 – View of plug tie-in at north bank of Hester Canal. Date of photo: 6-25-2008.*

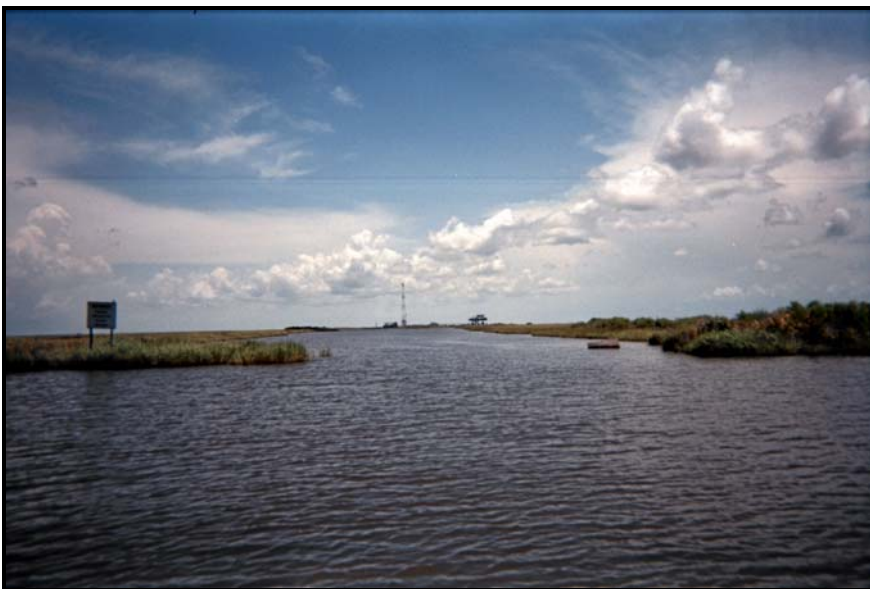
The shell plug located across Transco Canal north of Hester Canal is in poor condition. As noted in previous years' inspection reports, the shell plug has eroded in the center of the structure. According to the as-built and construction plans, the shell plug was constructed to elevation +4.0 NGVD. At the time of this inspection, the shell plug crest elevation was approximately 1.2 feet below the water elevation near the center. The shell tie-ins at the banks had no apparent signs of erosion. The west warning sign and supports were in good condition, but the east warning sign was missing. At this time repairing the shell plug is not recommended due to construction access constraints; however, this plug should continue to be monitored on future site visits.

Photo 6. *Plug No. 3A – View of location of shell plug 3A looking north inside Transco Canal. Top of shell plug is below water surface. Date of photo: 6-25-2008.*

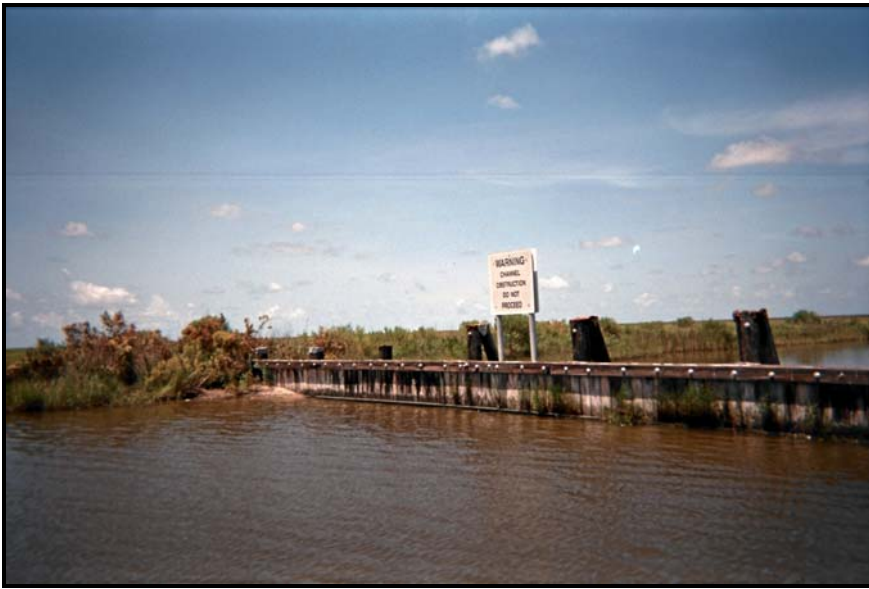
The timber bulkhead plug located on the west end of Hester Canal near Mosquito Bay appeared to be in good condition with no noticeable structural defects. The tie-ins at the banks had no apparent signs of erosion. The warning signs and supports were also in good condition. No maintenance will be required at Plug No. 1.

Photo 7. *Plug No. 1 – View of south bank tie-in of plug from east side of plug in Hester Canal looking west. Date of photo: 6-25-2008.*

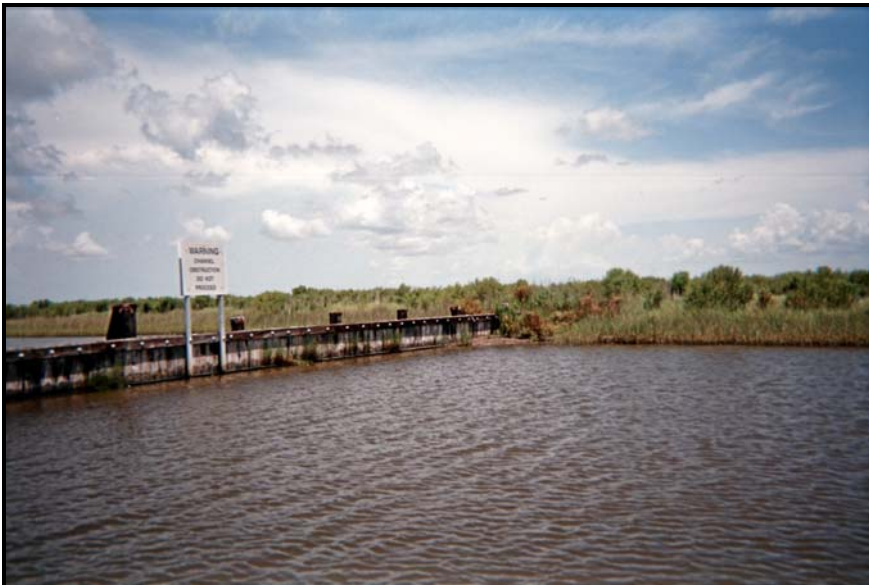
Photo 8. *Plug No. 1 – View of north bank tie-in of plug from east side of plug in Hester Canal looking west. Date of photo: 6-25-2008.*

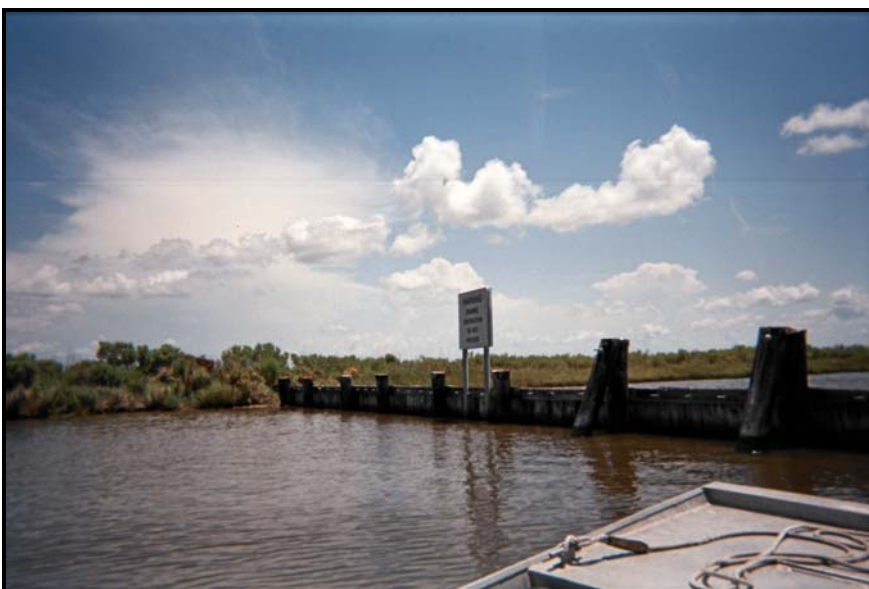
The timber bulkhead plug located across Hester Canal just west of Transco Canal appeared to be in good condition with no noticeable structural defects. The tie-ins at the banks had no apparent signs of erosion. The warning signs and supports were also in good condition. No maintenance will be required at Plug No. 2.

Photo 9. *Plug No. 2 – View of north bank tie-in of plug from west side of plug in Hester Canal looking east. Date of photo: 6-25-2008.*

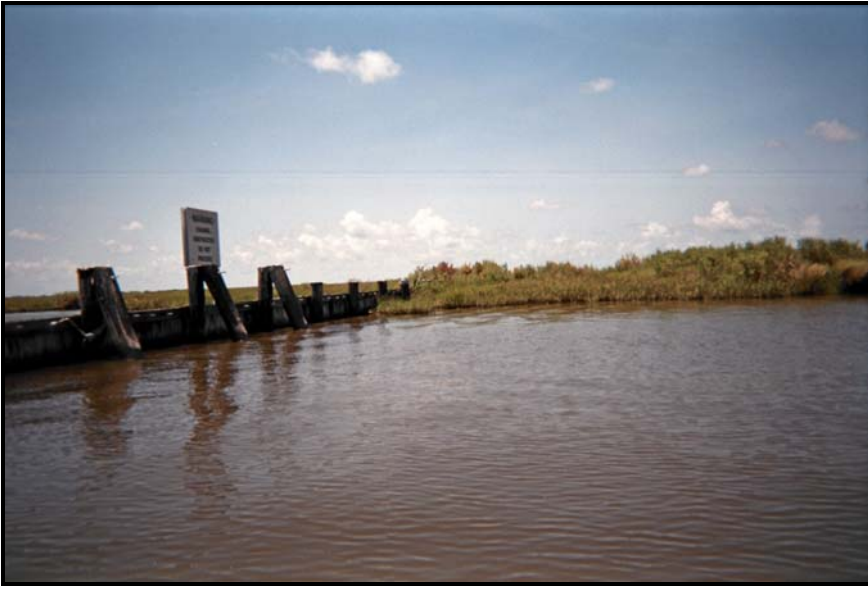
Photo 10. *Plug No. 2 – View of south bank tie-in of plug from west side of plug in Hester Canal looking east. Date of photo: 6-25-2008.*

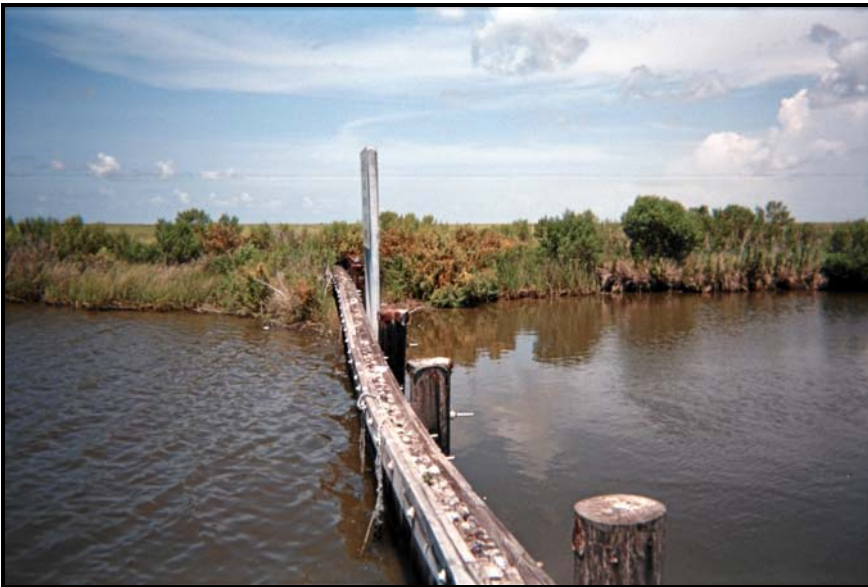
The timber bulkhead appears to be in good condition despite the existing deflection of the middle of the structure which occurred during construction. Both tie-ins appear intact with no apparent signs of erosion. The warning signs and supports were also in good condition. At this time no maintenance is recommended at Plug No. 6; however, the condition of the timber bulkhead should continue to be monitored on future site visits.

Photo 11. *Plug No. 6 – View of plug looking west along timber bulkhead in Transco Canal. Date of photo: 6-25-2008.*

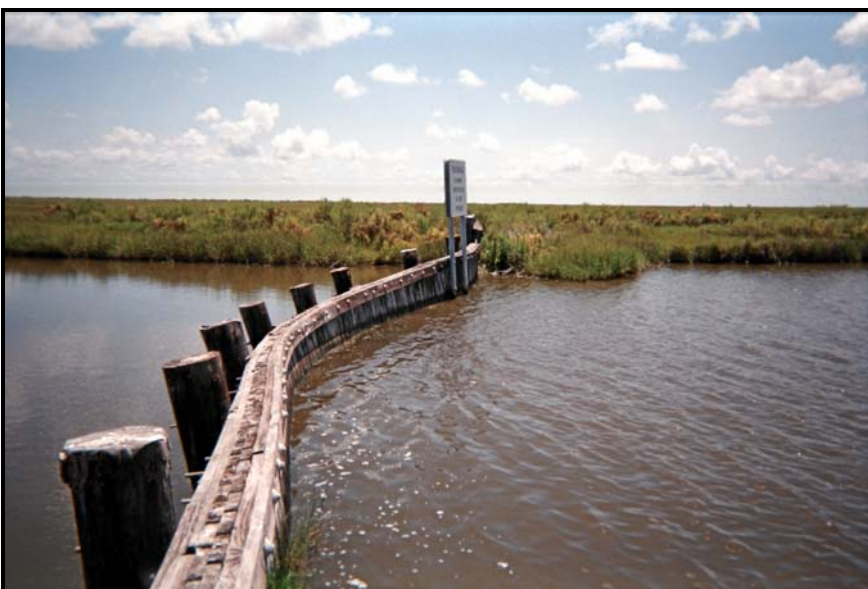
Photo 12. *Plug No. 6 – View of plug looking east along timber bulkhead in Transco Canal. Deflection from vertical of the bulkhead can be seen. Date of photo: 6-25-2008.*

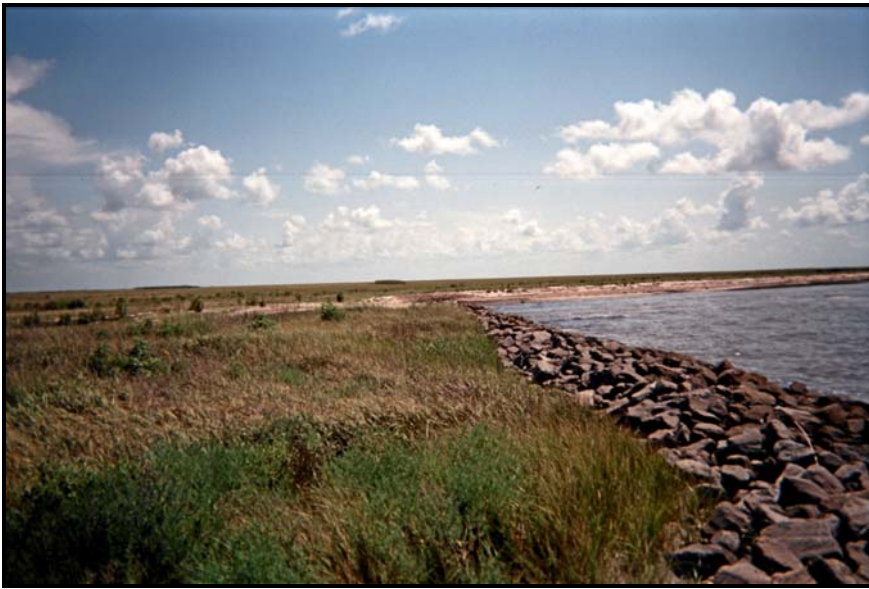
The erosion directly behind the east mats noted in previous inspections appears to have been slowed or halted as a result of the rock lift placed in 2005. Material has accreted behind the rock lift, and that deposited material is now densely vegetated. However, continued shoreline erosion was noted at the east end of the 2005 maintenance rock. Also, the rock dike appears to have settled. There is a small breach in the dike near the east tie-in that was a result of the 2005 hurricanes. The shoreline erosion here should continue to be monitored on future inspections. The western mats are in good condition, although shoreline erosion continues to increase near the end of the mats. There continues to be a small breach behind the existing bulkhead where water is passing behind the bulkhead and over the rocks and into Transco Canal. The steel sheetpile and tie-rods are heavily corroded and should continue to be monitored. No maintenance activities are recommended at this time other than continuing the annual inspections of the site.

Photo 13. *Plug No. 4A – View of east side of plug looking northeast toward shoreline. This is the additional lift of rock placed as part of the 2005 maintenance project. Area behind rock is now densely vegetated. Date of photo: 6-25-2008.*

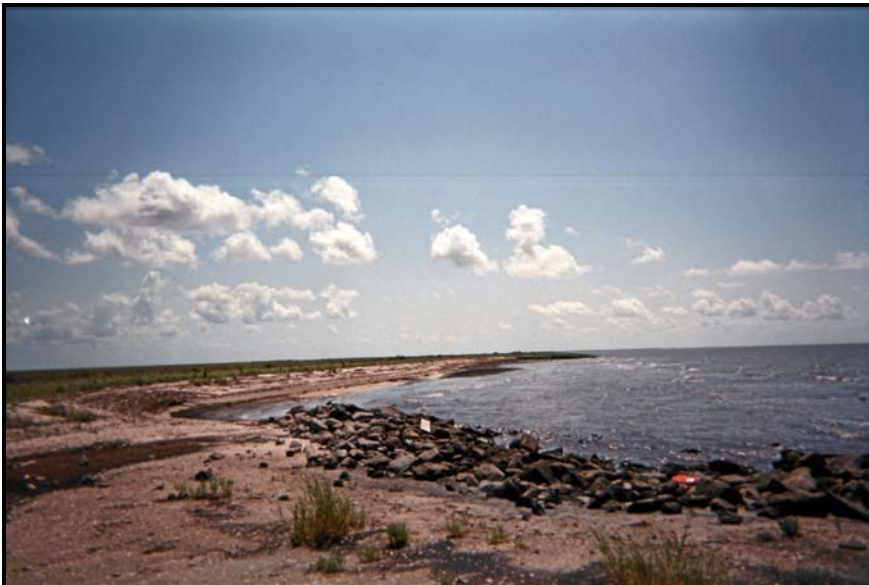
Photo 14. *Plug No. 4A – View of east shoreline tie-in of 2005 maintenance rock. Erosion pattern typical at termination point of shoreline rock can be seen. Date of photo: 6-25-2008.*

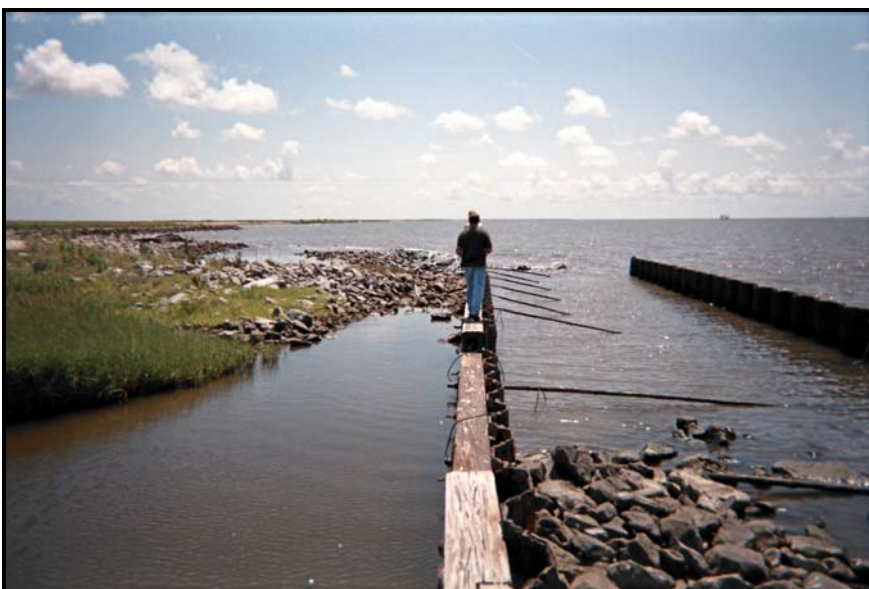
Photo 15. *Plug No. 4A – View of steel sheet pile bulkhead at the south end of Transco Canal looking east. Date of photo: 6-25-2008.*

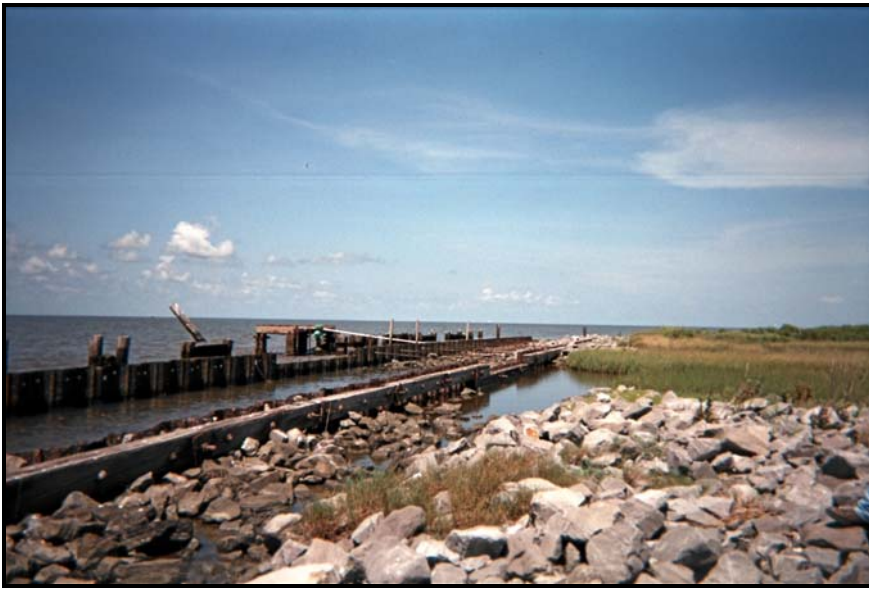
Photo 16. *Plug No. 4A – View of steel sheet pile bulkhead at the south end of Transco Canal looking west. Date of photo: 6-25-2008.*

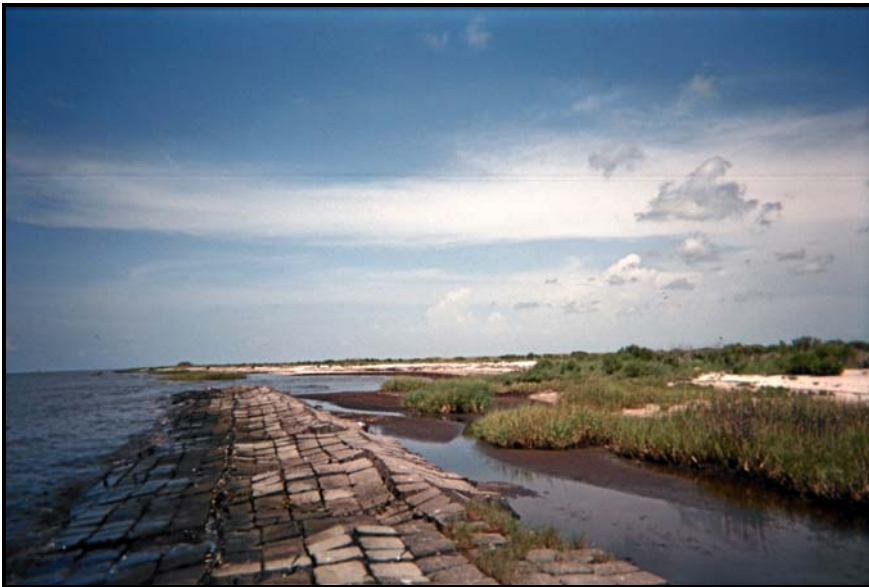
Photo 17. *Plug No. 4A – View of Petraflex mats on west side of plug looking west along shoreline. Erosion pattern typical at termination point of shoreline protection can be seen. Date of photo: 6-25-2008.*

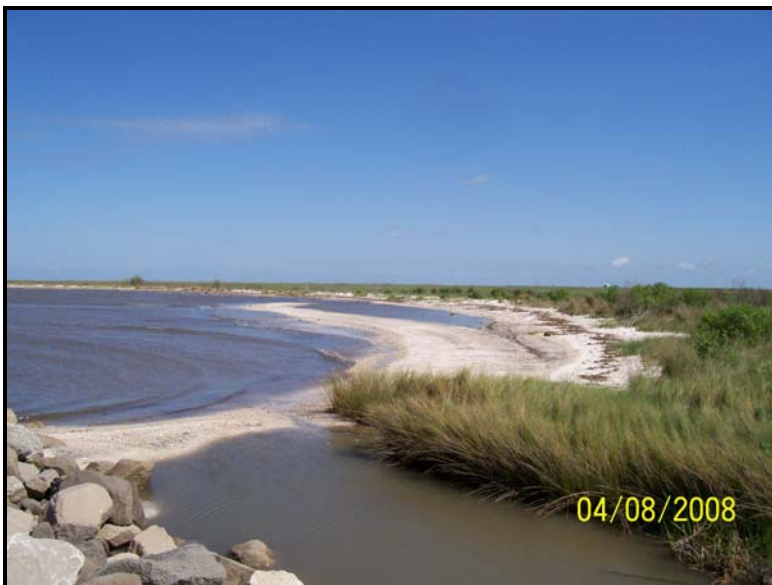
The rock dike along Area 5 of Phase III appeared to be in good condition with no noticeable settlement of the structure. Beyond the west end of the dike, erosion of the beach face was observed and should continue to be monitored on future site visits. No maintenance will be required in Area 5.

Photo 18. *Area 5 Rock Dike – View of west end of rock dike looking northwest along shoreline. Continued shoreline erosion can be seen just at the tie-in.*

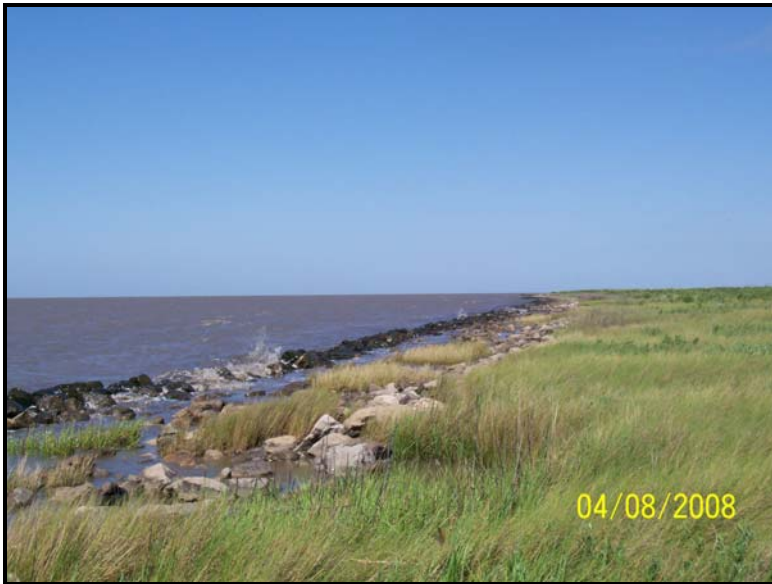
Photo 19. *Area 5 Rock Dike – View of rock dike looking northwest.*

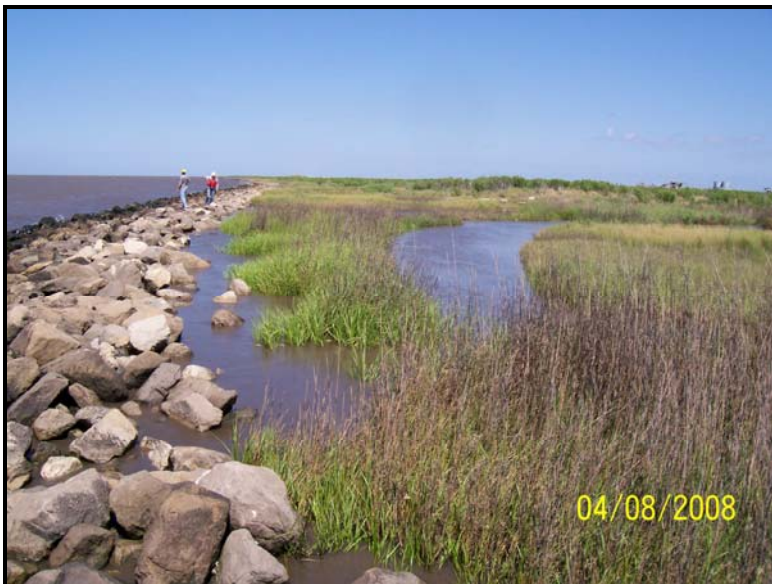
The breach around the east end of Area 4 rock dike noted in previous inspections was closed by the 2005 maintenance project with construction of approximately 300' of rock dike to the shoreline. Vegetation has been established behind rock dike in previous open water breach location. The new rock lift and extension dike appeared to be in good condition; however, continued shoreline erosion was noted at the east end shoreline tie-in and should continue to be monitored on future inspections. Also, the small area of displaced rocks near the east end was due to the 2005 hurricanes as noted in the 2006 inspection report. It appears that some settlement has occurred along sections of the dike and should continue to be monitored on future inspections. No maintenance will be required in Area 4.

Photo 20. *Area 4 Rock Dike – View of rock dike looking northwest.*

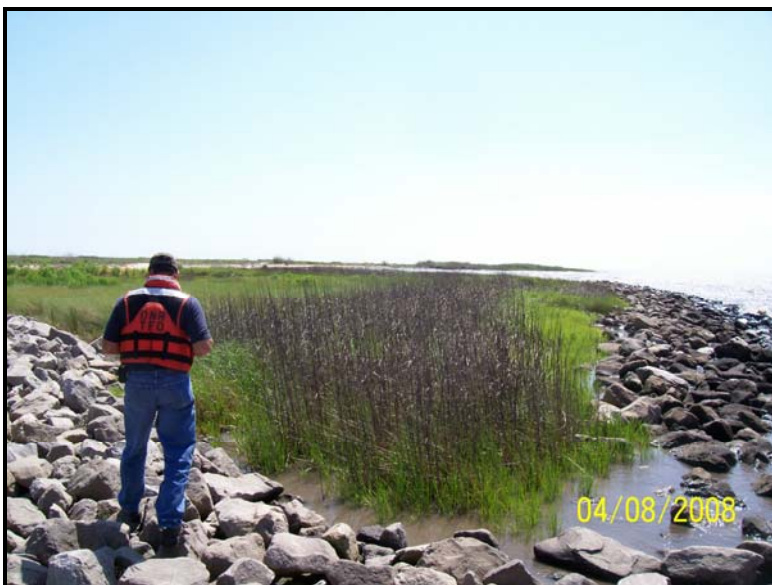
Photo 21. *Area 4 Rock Dike – View of rock dike looking southeast. The rock spur plug extending from the dike installed as part of 2005 maintenance can be seen on the left. Previous open water breach behind dike is now densely vegetated.*

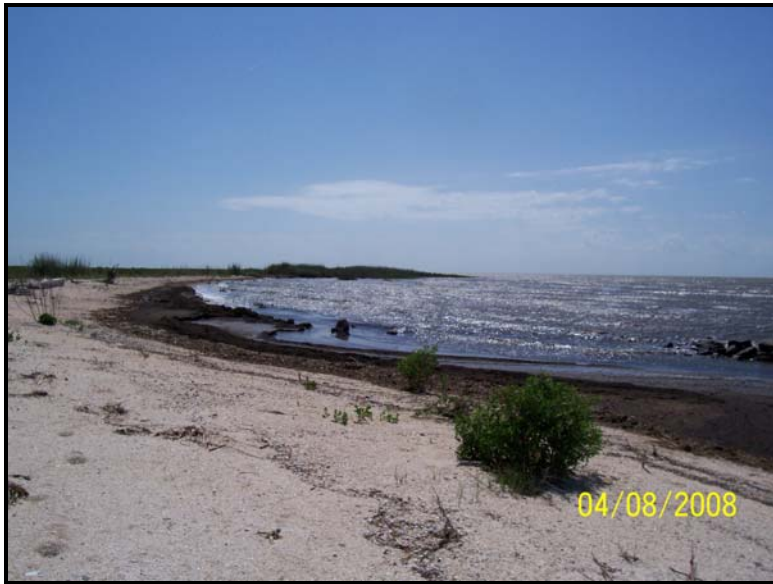
Photo 22. *Area 4 Rock Dike – View of east end of 2005 maintenance rock looking southeast from shoreline. Continued shoreline erosion can be seen at tie-in and beyond.*

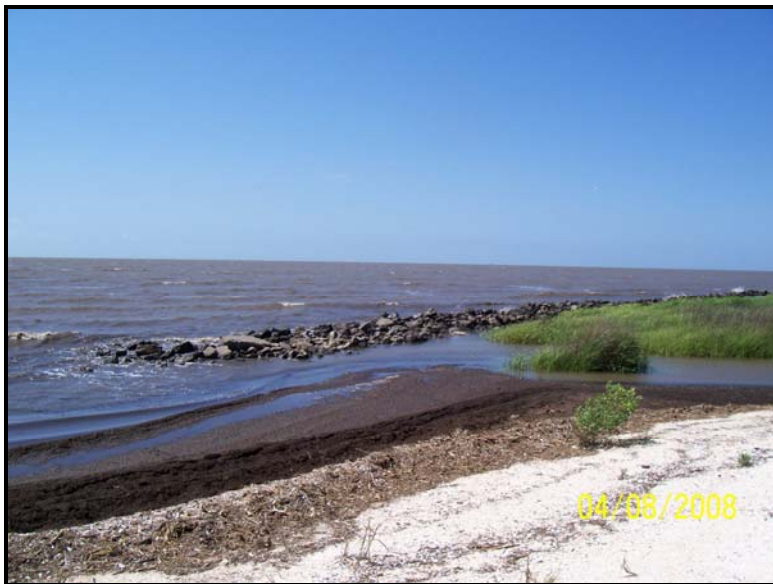
Photo 23. *Area 4 Rock Dike – View of east end of 2005 maintenance rock looking west from shoreline.*

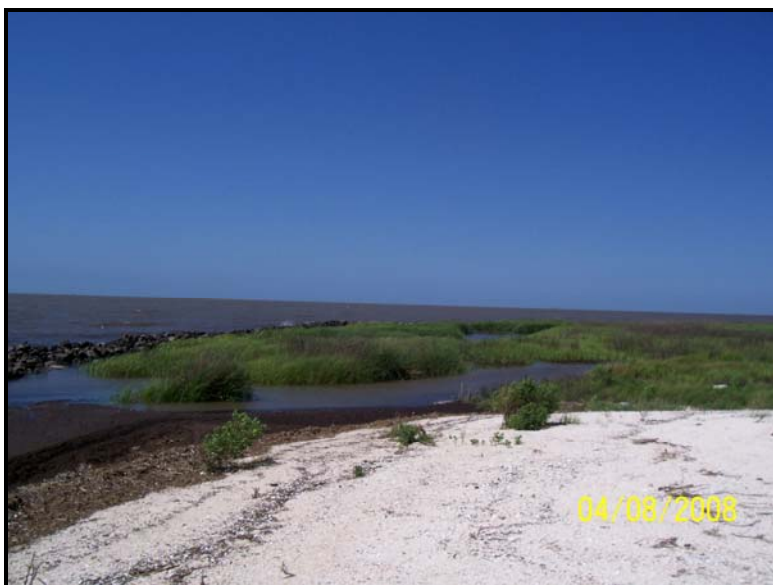
Photo 24. *Area 4 Rock Dike – View of 2005 maintenance rock at east end of Area 4. Previous open water breach behind dike is now vegetated.*
